**SERVICE INFORMATION**

Bulletin Nbr: 811-1941

**Noise from soft top cover drive unit/soft top cover will not open**

Saab 900 CV M95 -M98

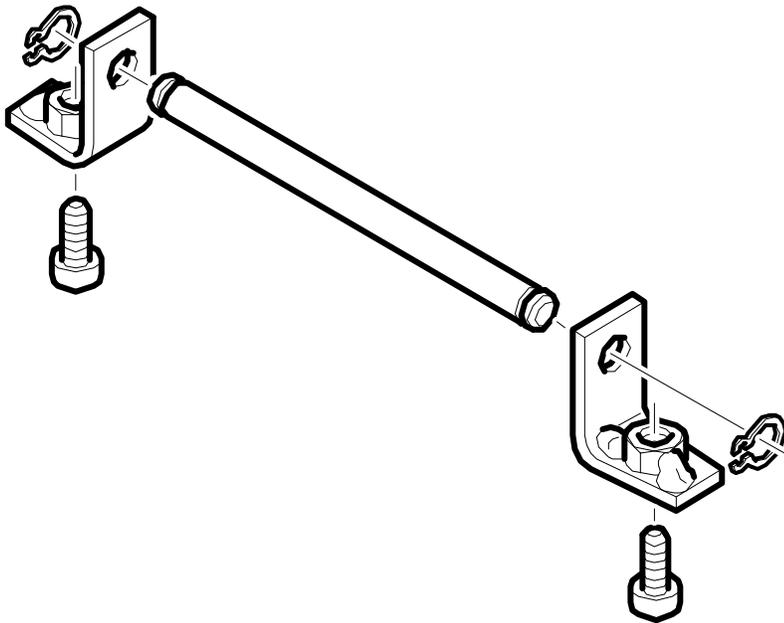
D811B647

Deformation of the drive unit gearcase or the aluminium plate securing the motor to the gearcase has occurred on certain occasions, especially on cars where the soft top is operated frequently. This can increase the clearance between the gears on the motor and the gearcase. If the clearance becomes too great, the gears will be damaged and noise will occur. The motor may also be "disengaged" completely, preventing the soft top from being operated.

The addition of these reinforcing brackets can make a soft top (Tonneau) cover drive unit operable again and prevent further deterioration.

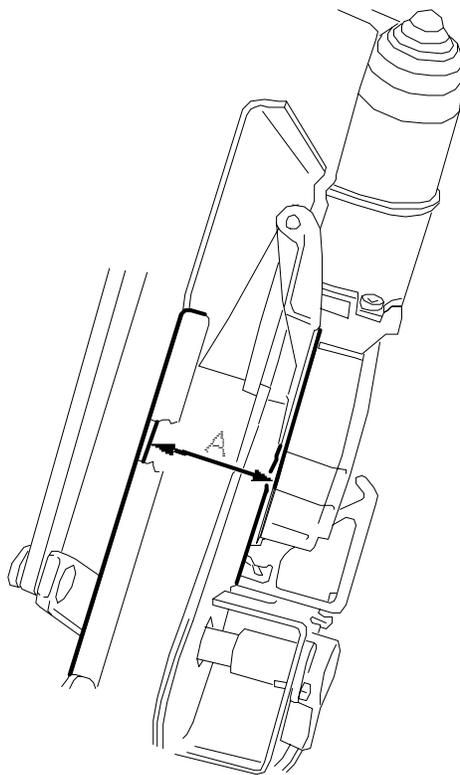
D811B648

1. Remove the soft top cover drive unit, see "8. Convertible, Adjustment and replacement, Soft top cover motor" → .
2. Place the drive unit on a workbench.
3. Make sure the motor is connected correctly to the gearbox mechanically and check the distance A in the illustration.

If A exceeds 36 mm, the drive unit must be modified in accordance with this Service Information unless any of the following damage has occurred.

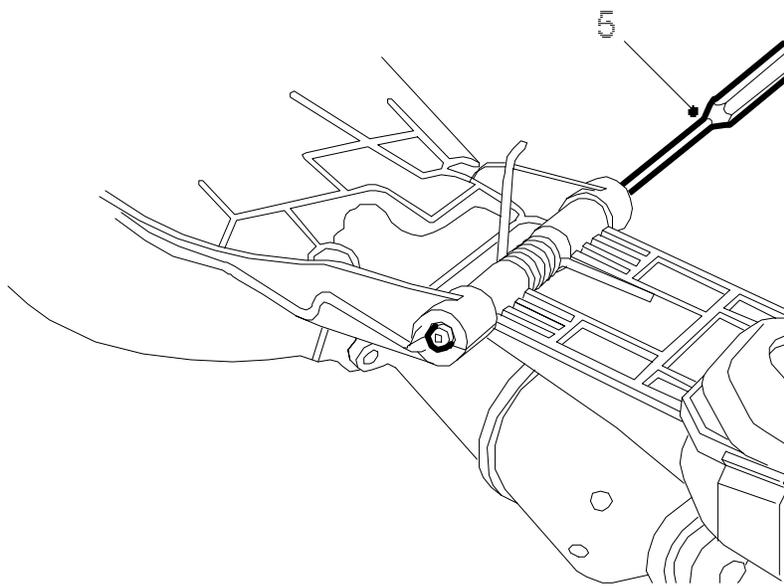
D811B651

6. If the gearcase has been deformed it can be aligned in the following way:

Refit the pin into the gearcase. Support the gearcase in a vice and align it to its original shape by twisting with a pipe wrench or large adjustable pliers.
