Subject: Correcting Complaint of Exhaust Vibration Caused by Broken Catalyst Support Bracket

**Application: Certain 1994 and 1995 900 Models
See VIN Serial No. Ranges below**

CATEGORY		Engine	
SECTION	2	PAGE	54
ISSUE	05/95-0579	CODE	254

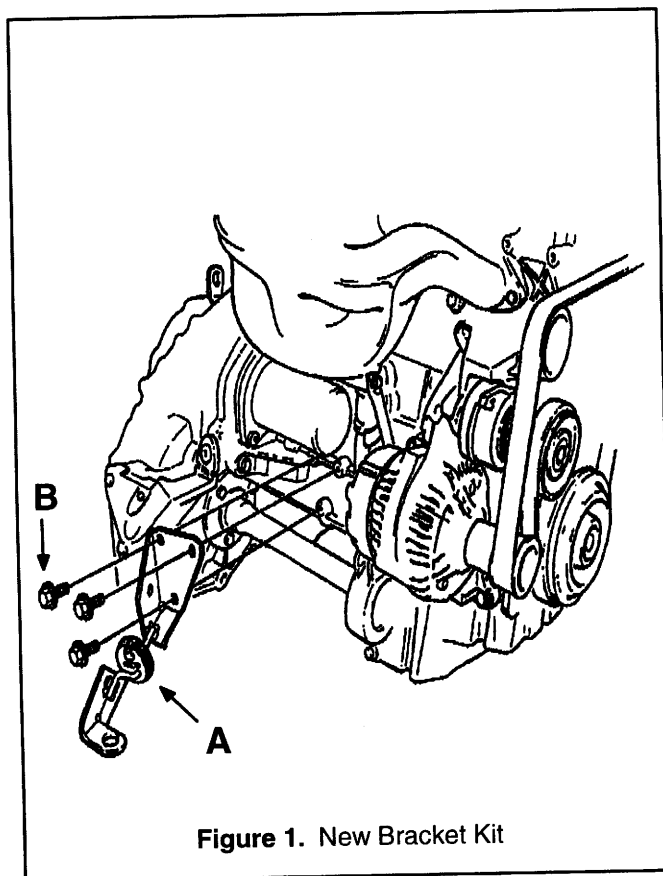
Figure 1. New Bracket Kit

If a customer complains of a very loud exhaust vibration, check that the steel bracket installed between the engine and catalytic converter has not broken. If upon investigation this bracket is found to be cracked/damaged, it can be replaced with a newly-developed spare parts kit as described below.

1. Join the two brackets with the rubber suspension block. See Figure 1, item A.
2. Raise the car and remove the old holder. Scrap all bolts and washers.
3. On the engine, clean the threads of the hole for the bolt at top left.
4. Fit the new holder to the engine by means of three bolts. Do not tighten the bolts. See Figure 1, item B.

5. Screw the holder to the exhaust pipe with the spacer between the holder and the catalytic converter.

Before tightening, check that the rubber suspension block is positioned vertically.

Tightening torque: 20 Nm (15 ft.lbs.).

6. Tighten the bolts securing the holder to the engine.

Tightening torque: 20 Nm (15 ft.lbs.)
