TECHNICAL SERVICE BULLETIN

TSB No. 210-2570	Date September 2005	9-5
Distr. all

Whistling noise from brake servo system

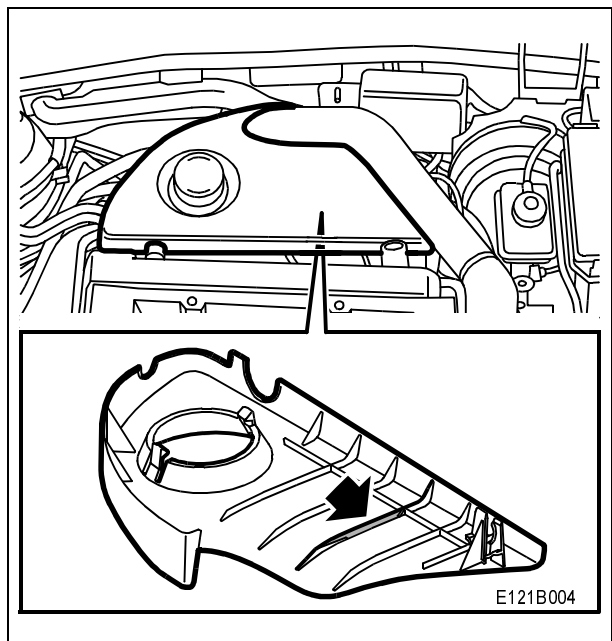
In some cases, the upper engine cover makes a hole in the brake servo vacuum hose.

Whistling noise from the brake servo system in the engine compartment.

- 1 Remove the upper engine cover.
- 2 Use a knife or the like to remove all of the edging in the engine cover. See illustration. Be sure not to leave any sharp edges.
- 3 Replace the vacuum hose.
- 4 Fit the upper engine cover.
