SERVICE INFORMATION

Bulletin Nbr: 845-2282

Market: AT, AU, BE, CA, CH, CR, DE, ES, FI, FR, GB, GR, HK, HU, IE, IT, JP, NL, NO, PL, PT,
RU, SE, TR, TW, US, ZA**Rear spoiler vibrates and rattles**

Saab 9-3 Viggen from M99 to M01 VIN 17016680.

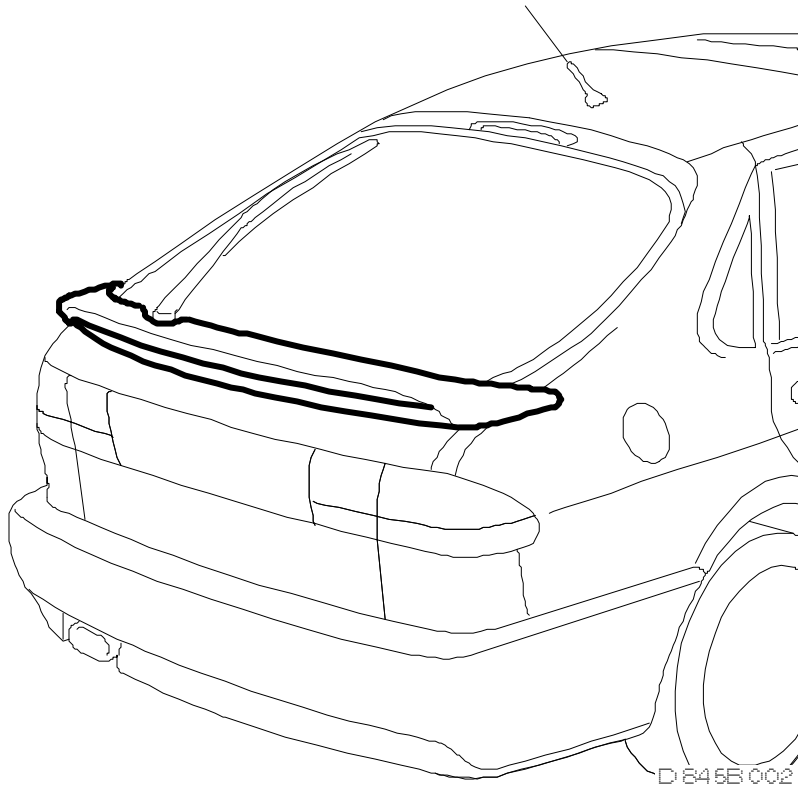
The outer mountings of the rear spoiler can warp, causing the spoiler to vibrate. This causes rattles and can damage the paintwork of the boot lid.

Rattles and vibrations from the rear spoiler.
