TECHNICAL SERVICE BULLETIN

TSB No. 210-2418 ed. 4	Date April 2006	9-3 (9400)
Distr. all

Oil leakage from engine

Saab 9-3 (9400) M99 - M03 with engine variants B205 and B235

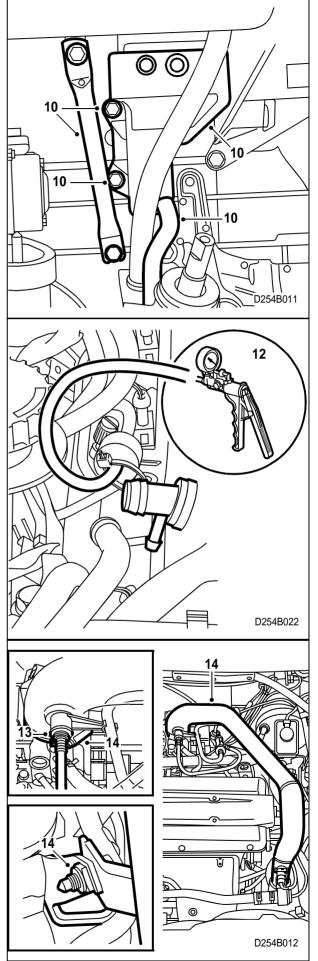
Arrow's direction on the check valve.

12 Check the function of the check valve on the small circuit with 30 14 883 Pressure/Vacuum pump, replace if necessary. The arrow must point toward the throttle body.
