SERVICE INFORMATION

| SI No. 210-2417 | Date October 2003 | 9-5 |

Oil leakage from engine, replaces SI 210-2353

Saab 9-5 M98 - M03 with engine variant B205 and B235

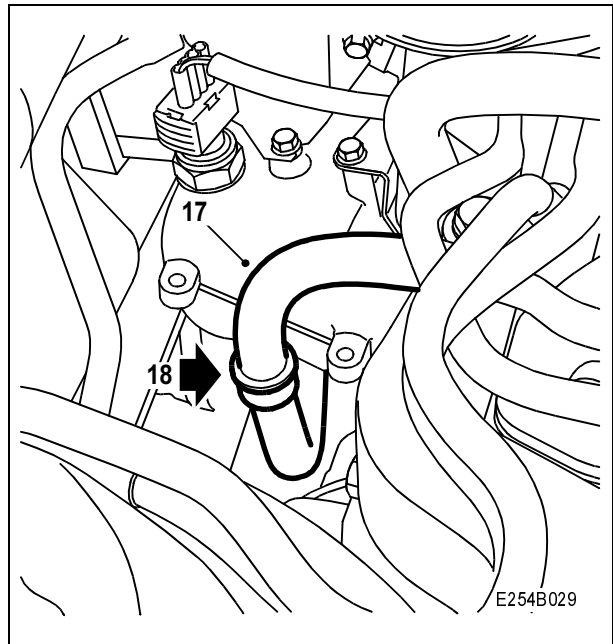
- 17 Cut the hose to the turbo inlet pipe to a height level with the intake manifold.
- 18 Fit the check valve/reducing valve.

The direction of the arrow must be pointing upward (from the oil trap to the turbo). Note too that the check valve/reducing valve does not stop the air flow in the opposite direction but only reduces the air flow.
