**SERVICE INFORMATION**

Bulletin Nbr: 811-1941

**Noise from soft top cover drive unit/soft top cover will not open**

Saab 900 CV M95 -M98

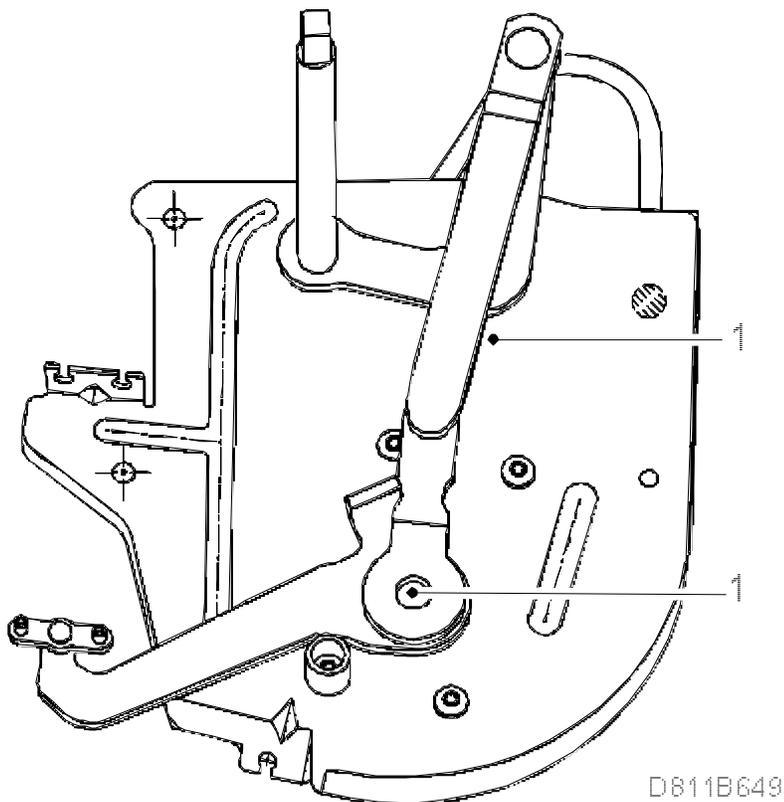
If A exceeds 36 mm, the drive unit must be modified in accordance with this Service Information unless any of the following damage has occurred.

- that the catch is not damaged
- that there are no fractures in the gearcase. A certain deformation of the bracket securing the spindle for the motor's aluminium plate is acceptable, however. Any realigning can be carried out in connection with the modification.

If any of the above damage has occurred, the soft top cover drive unit must be replaced with a new one, see "8. Convertible, Adjustment and replacement, Soft top cover motor" → .
