SERVICE INFORMATION

Bulletin Nbr: 845-2282

Market: AT, AU, BE, CA, CH, CR, DE, ES, FI, FR, GB, GR, HK, HU, IE, IT, JP, NL, NO, PL, PT,
RU, SE, TR, TW, US, ZA**Rear spoiler vibrates and rattles**

Saab 9-3 Viggen from M99 to M01 VIN 17016680.

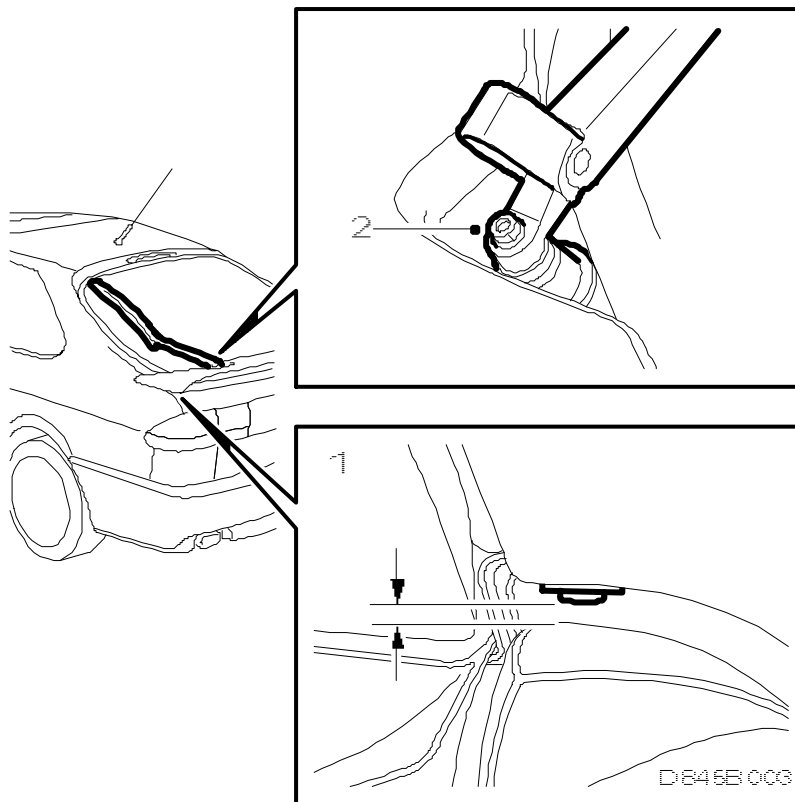
The outer mountings of the rear spoiler can warp, causing the spoiler to vibrate. This causes rattles and can damage the paintwork of the boot lid.

1. To avoid problems after fitting the spoiler, check that the bolts of the outer mounting do not rub against the rear fenders. If the bolts lie too near the fenders, adjust the boot lid. See WIS group 8, "Doors and locks", Adjusting, replacing, "Bumper control, boot lid".

Check that the lid support is correctly adjusted, i.e. lies against the body support.
